## Hundertbücheln - Mobile Construction Site Documentation Teacher's House

Churchfortress e.V.

# Construction Site Documentation 04.07. - 13.07.2016

## Teacher's House

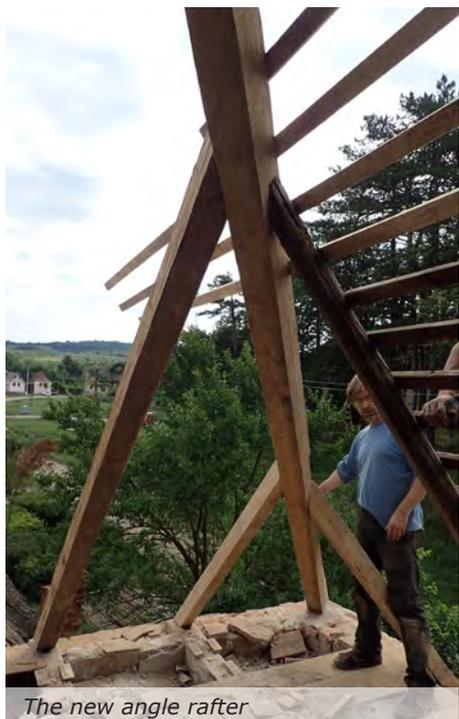
The new angle rafter

In the afternoon the rain stops and we can uncover the roof at the front side of the house about halfway. The old angle rafter is being removed and replaced with a new beam. The same applies to the adjacent rafters. The moulding gets bricked up to original height all around. All the rubble is removed from the roof.

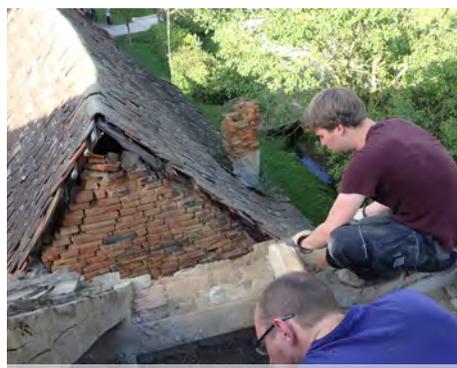
The moulding is being bricked up

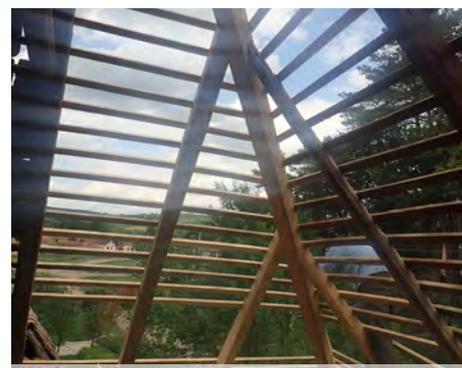
New roof battens are put in

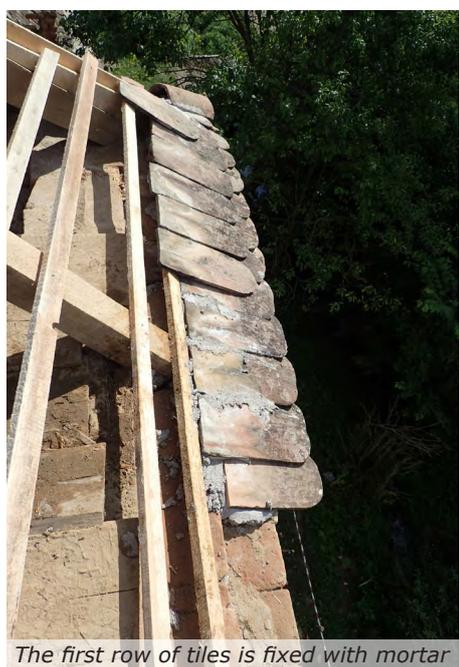
The first row of tiles is fixed with mortar

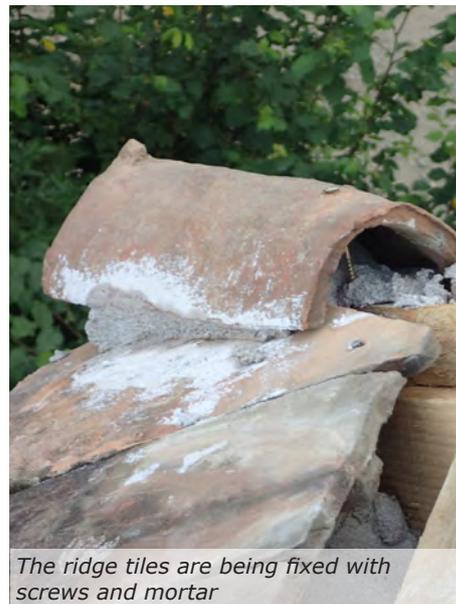
The ridge tiles are being fixed with screws and mortar

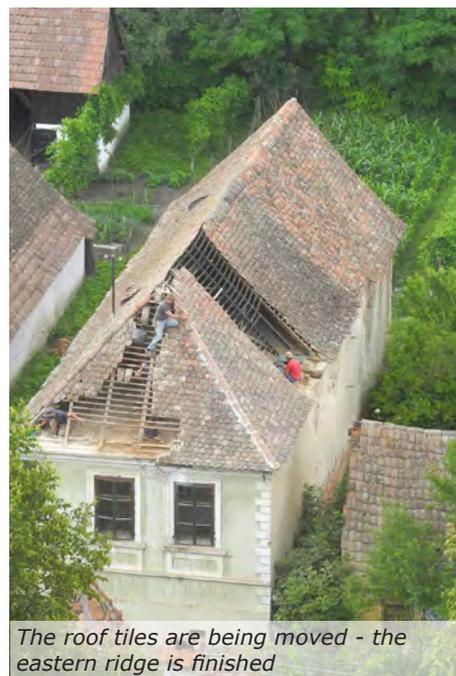
The roof tiles are being moved - the eastern ridge is finished

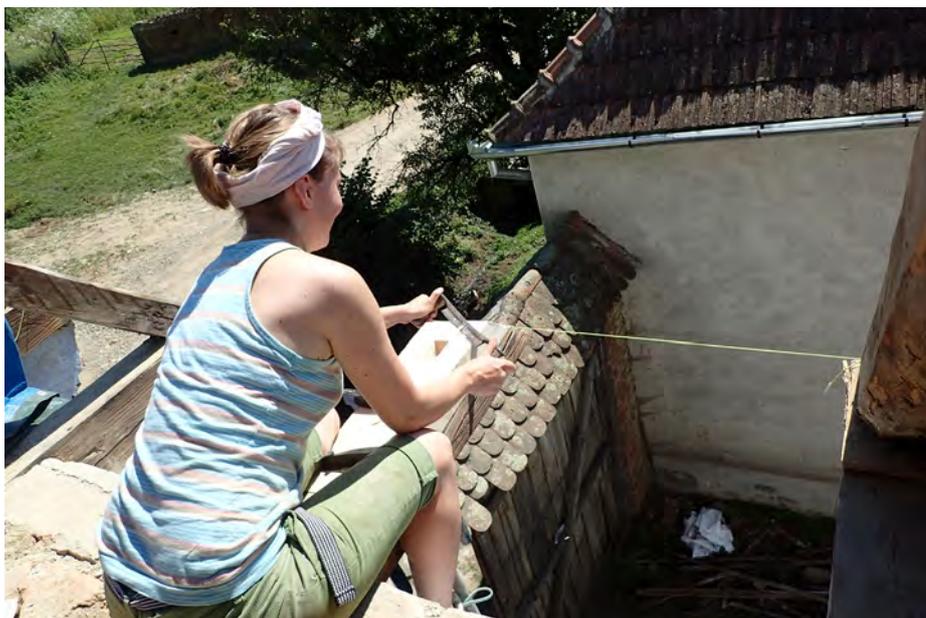
The timber joint on the western side gets fitted exactly

The timber joint at the western side is being completed and the rafter gets fitted in. The rest of the group takes a well-deserved day of rest.

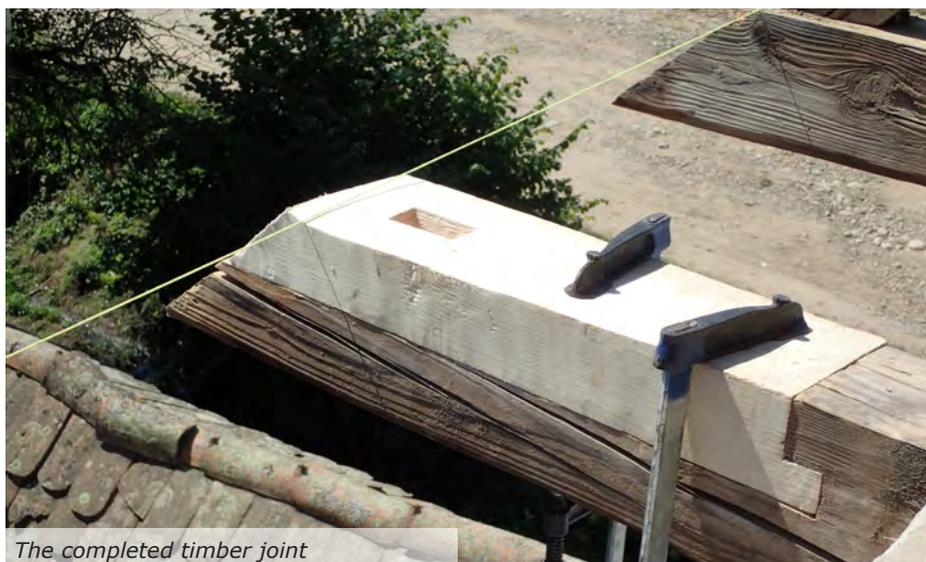
The completed timber joint

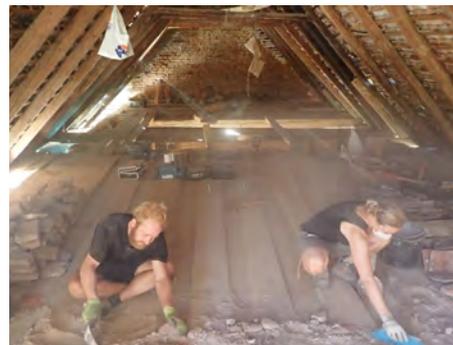
*Removal of bricks and rubble*

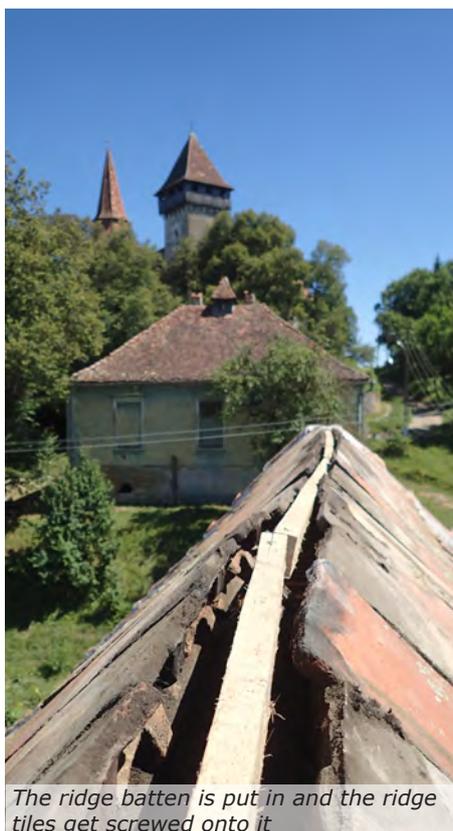
*The ridge batten is put in and the ridge tiles get screwed onto it*

The ridge tiles on the angle ridge of the **Teacher's House** are being fixed with screws and mortar. With this step the angle ridge on this side is finished as well. In the front third of the roof a batten is fixed on the ridge and the ridge tiles screwed onto it. The remaining bricks on the floor of the attic are being removed and the plank floor gets uncovered completely. On the western side new roof battens are being fixed and additional roof tiles from the basement or ground floor are brought up into the attic.

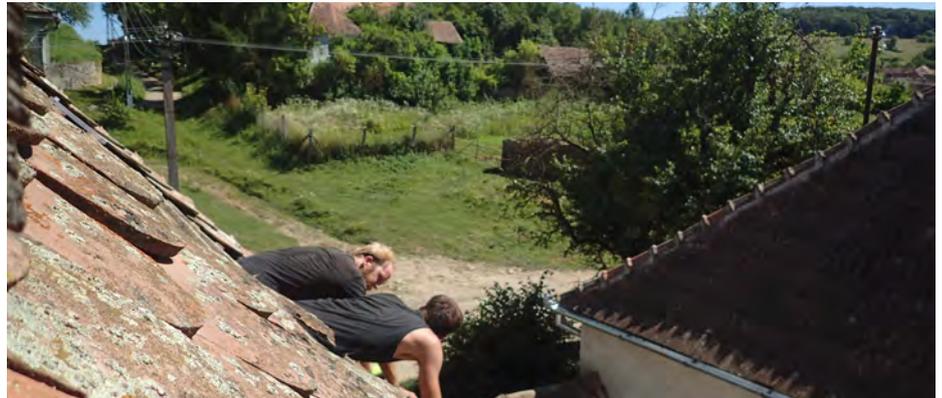
*The last roof battens are being fitted, put in and fixed*

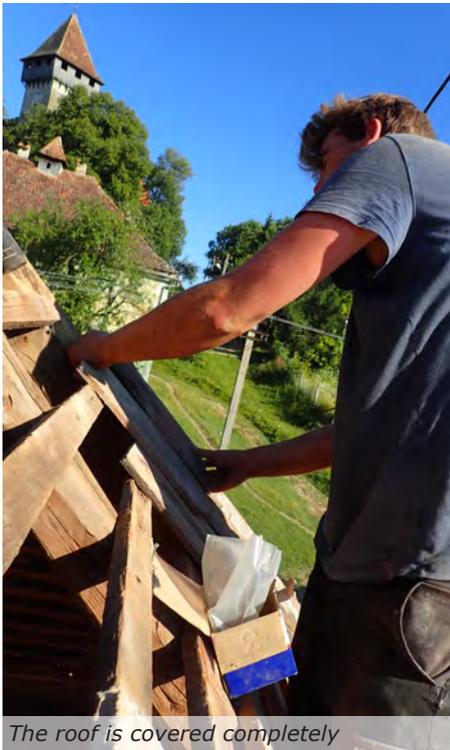
*The roof is covered completely*

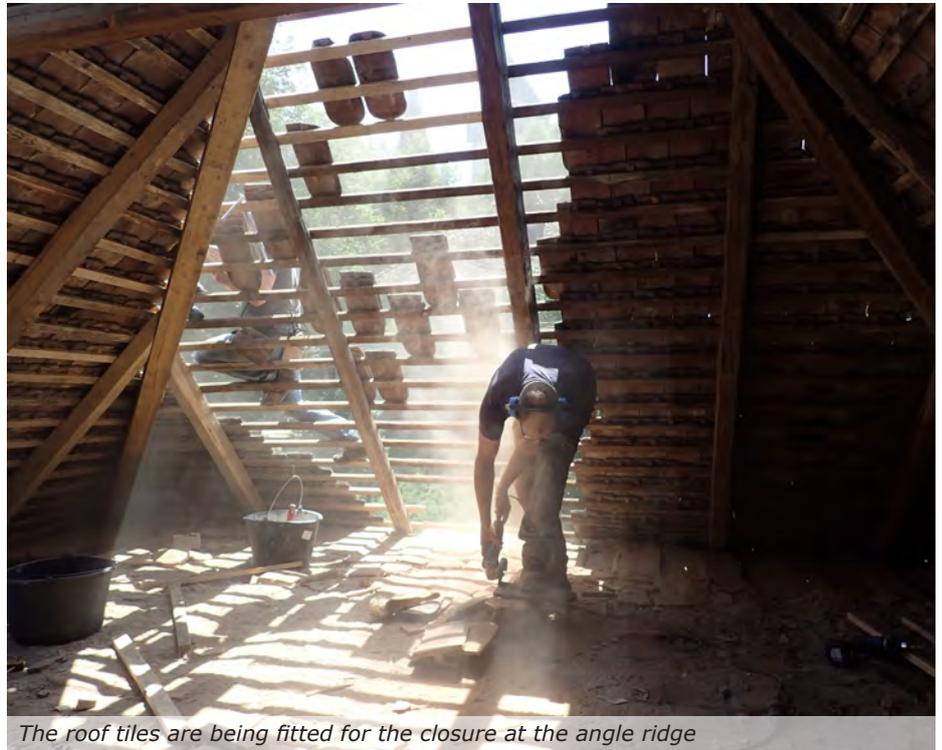
*The roof tiles are being fitted for the closure at the angle ridge*

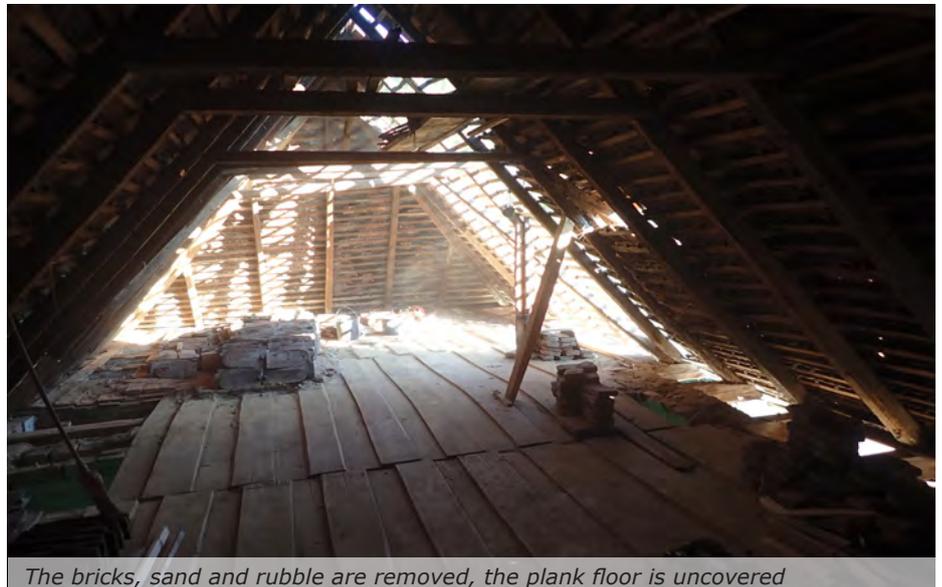
*The bricks, sand and rubble are removed, the plank floor is uncovered*

The construction site at the Teacher's House is finished for this year. It was possible to repair the entire front third of the roof. All the rubble was brought down from the attic and the underlying plank floor was uncovered.
